The attached report contains the findings of the **Tulalip Quil Ceda wastewater (MBR) system** survey conducted on **October 23, 2012**. The survey was conducted by Karin Knopp(IHS), Jason Schneider (IHS), and Mike Cooney (Tulalip Tribes). Present during the survey were Lukas Reyes (interview portion); and field workers Jeremy and Jaret (plant, pump station, and drainfield tours).

Liquid Waste Survey

Tulalip CSS-Quil Ceda MBR
8802 27th Ave NE
Tulalip, WA 98271
(360) 716-5000

Survey Date: 10/23/2012
Time In: 10:00 AM
Time Out: 3:00 PM
Survey Purpose: Routine

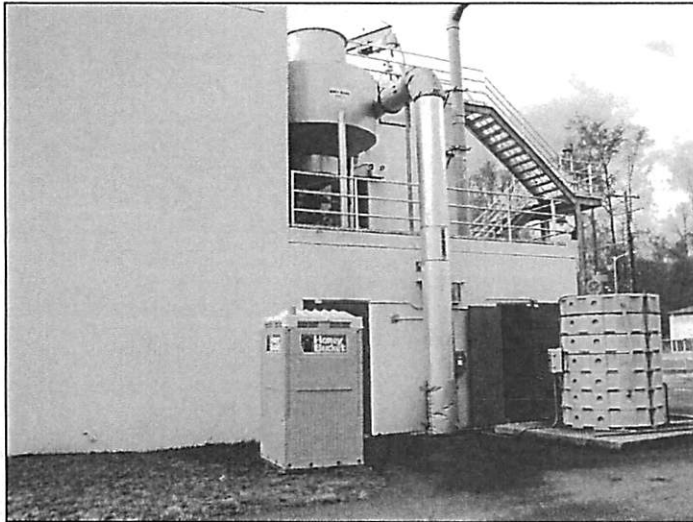
Picture 1

4) This facility has one portable toilet, but lacks lockers, showers, washer dryer, and hand wash sinks. This is a hinderance to operator hygiene. These facilities not only help to protect the operators health, but can increase their effectiveness in that they aren't required to leave in instances where their clothing has become soiled. Similar MBR plants that are of more recent construction have included all of these facilities. As a further recommendation, these facilities should be available for both genders. (OSHA 1910.141(d-f)). See picture 1.

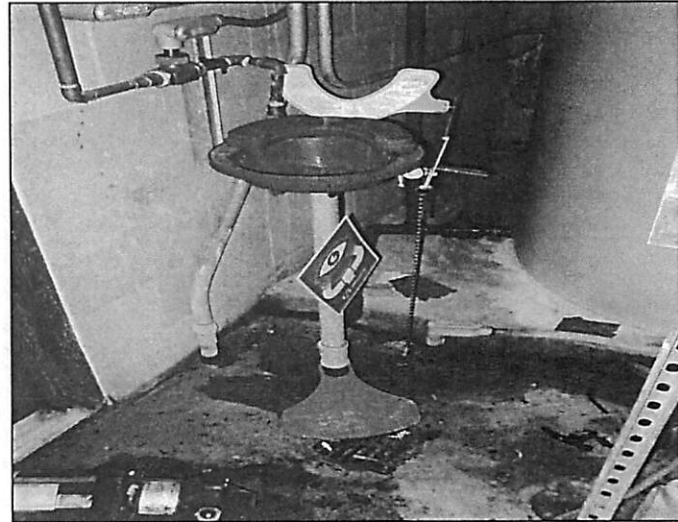
Picture 2

2) The emergency eye wash in the chlorine room is not in working order, posing a greater risk of injury to operators in the case of chemical splash. (OSHA 1910.151(c)). See picture 2.

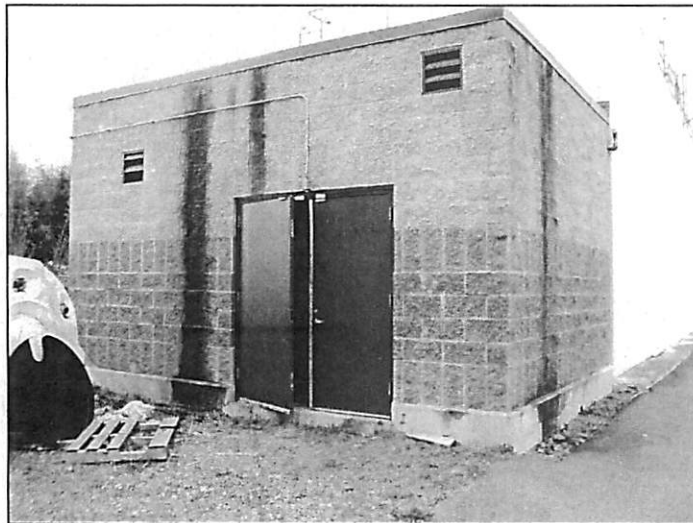
Picture 3

5) Recommend additional placards to identify the sodium hypochlorite room (within the Effluent building) for operator and emergency responder safety. It is recommended to use both placard examples shown at the end of this report. When ordering these placards, use the term "sodium hypochlorite" indicating the liquid form of chlorine. The term "chlorine" describes chlorine gas. See picture 3.
